DAVID W. TAYLOR NAVAL SHIP
RESEARCH AND DEVELOPMENT CENTER
Bethesda, Md. 20084

STRUCTURES DEPARTMENT
RESEARCH AND DEVELOPMENT REPORT

REPORT DOCUMENTATION PAGE		READ INSTRUCTIONS BEFORE COMPLETING FORM
1. REPORT NUMBER Report 77-0102	2. GOVT ACCESSION NO.	3. RECIPIENT'S CATALOG NUMBER
4. TITLE (and Subtitle) 6 FABRICATION OF PRESSURE TANK USING HY-1ØØ STEEL.		5. TYPE OF REPORT & PERIOD COVERED 6. PERFORMING ORG. REPORT NUMBER

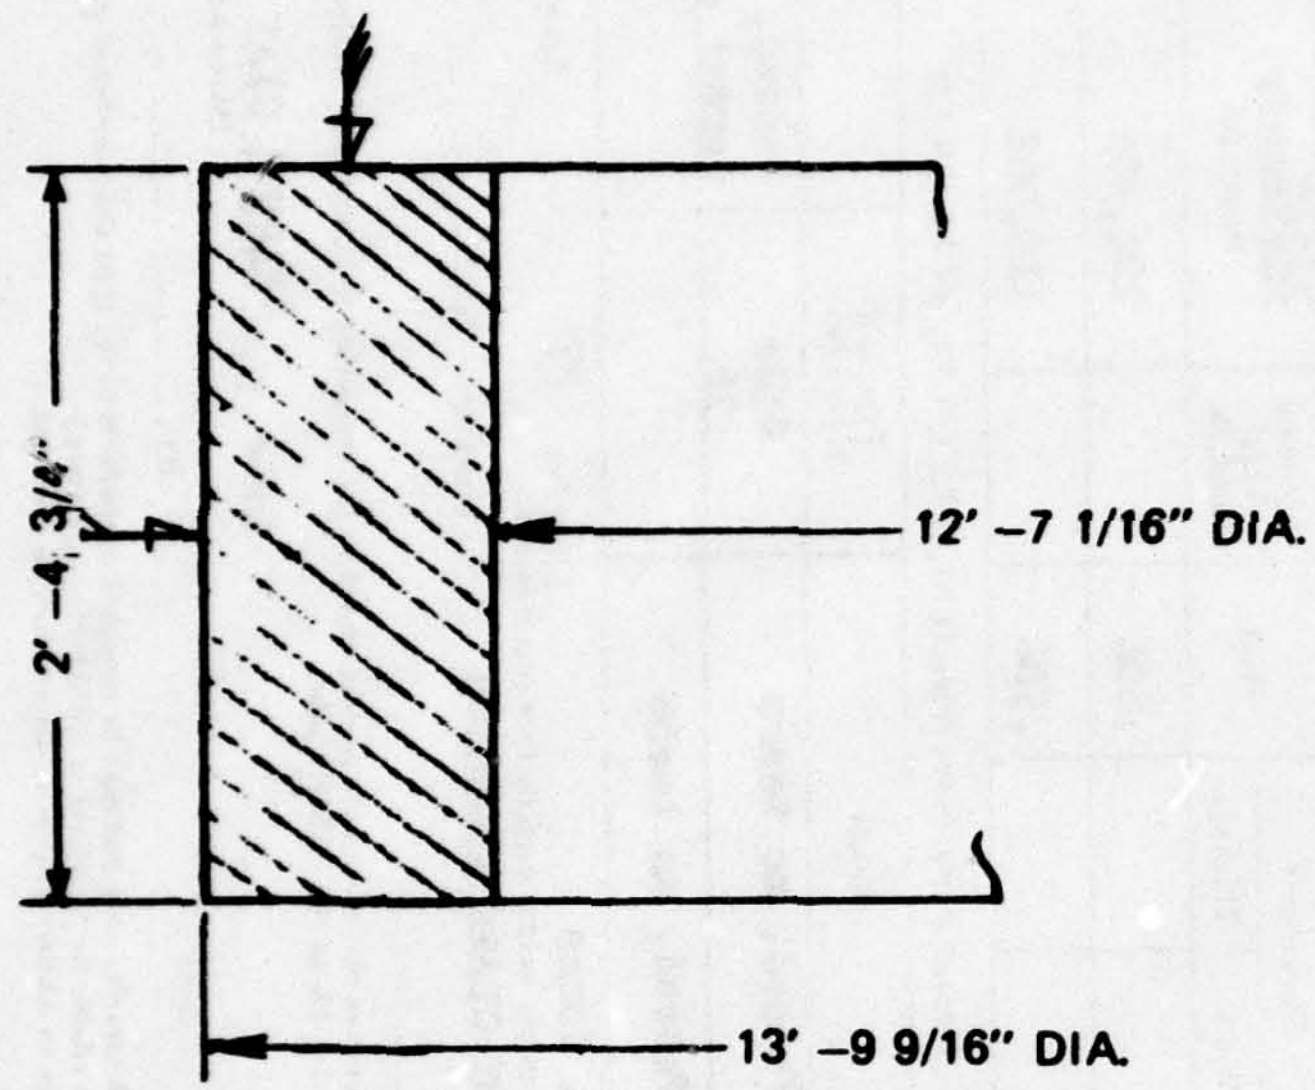
NOTE: ITEM 2 HAD (12) DEFECT AREAS CAUSED BY SCALE IN THE END OPPOSITE THE PROLONGATION END. INDICATIONS VARIED FROM 1/4" –2" LONG. MAXIMUM DEPTH WHEN REMOVED BY GRINDING 17MM (0.669") FINISH MACHINING WILL ELIMINATE ALL OF THESE DEFECTS.

SEE NSRDC AUDIT FINDING 3

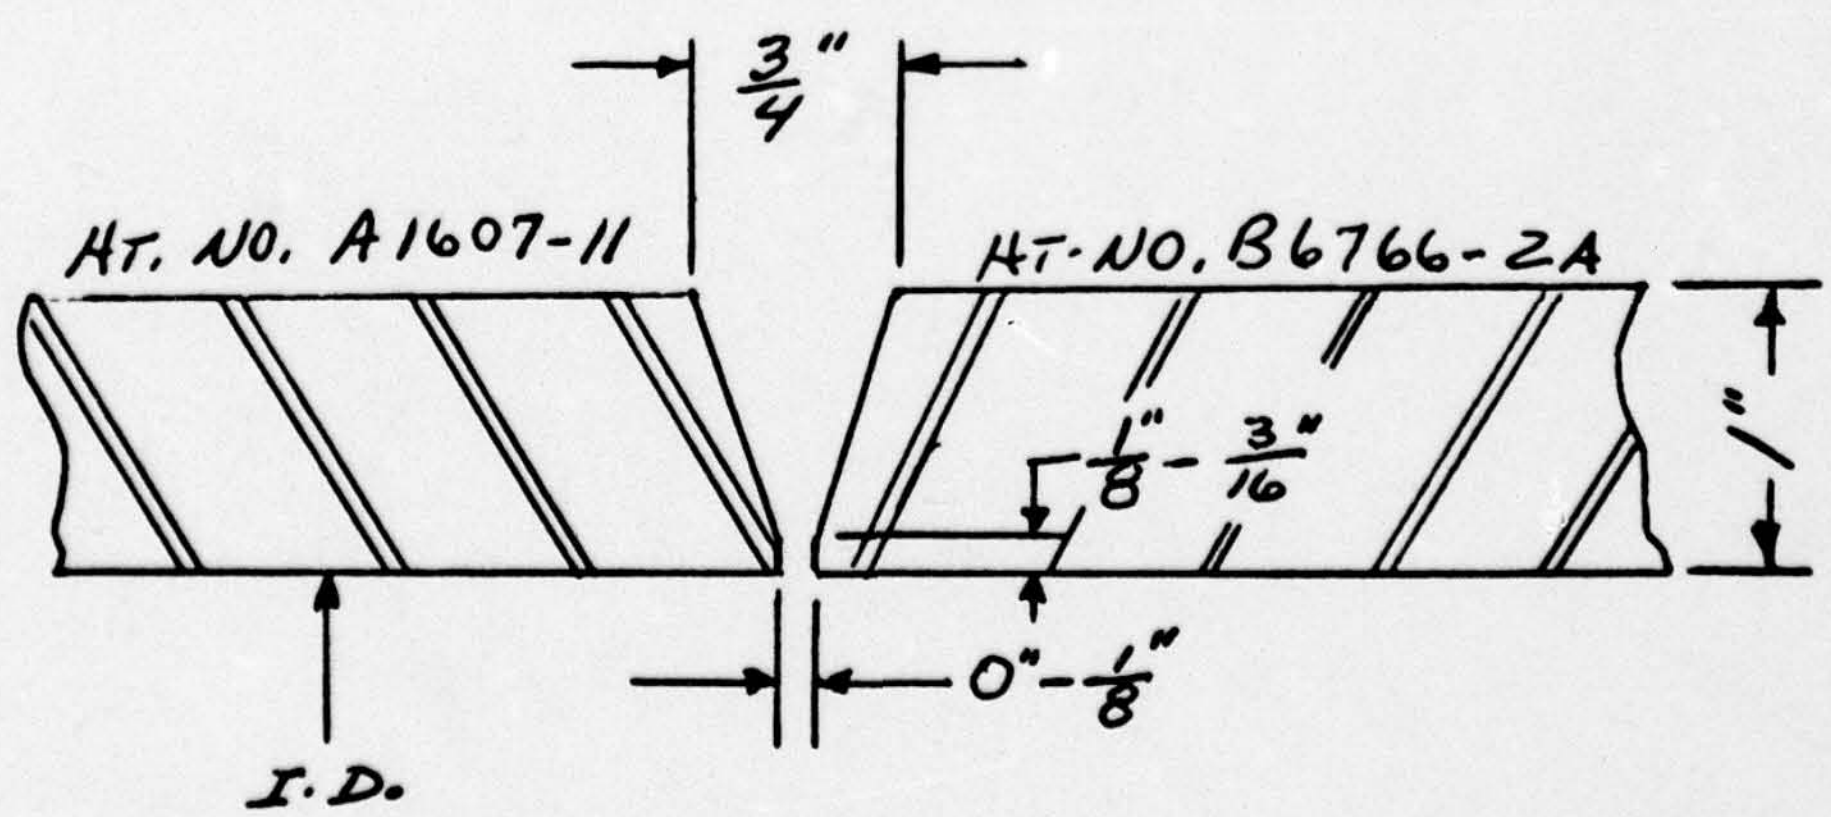
HAHN & CLAY INSPECTION RECORD - A

DETAILS: RADIOGRAPHY EXAMINATION OF THE WELD SEAMS REVEALED NO INDICATIONS OF UNACCEPTABLE DEFECTS IN LS-1. WELD SEAM LS-2 WAS REJECTED DUE TO A CRACK IN

DETAILS: RESHOT RADIOGRAPHY TO VERIFY THE CRACK IN THE WELD SEAM. THE RADIOGRAPHY CONFIRMED A CRACK IN EXPOSURE 9-10.

DETAILS: MAGNETIC PARTICLE EXAMINATION OF THE REPAIRED WELD SEAM REVEALED NO INDICATIONS OF UNACCEPTABLE DEFECTS. NOTE: THE WELD SEAM WAS REPAIRED IN

~~ACTION TAKEN~~: THE AREA OF EXPOSURES 9-10, THE REPAIR
